APOLLO 16 MISSION
ANOMALY REPORT NO. 5

HOLES IN CANOPY OF MAIN PARACHUTE

MANNED SPACECRAFT CENTER
HOUSTON, TEXAS
DECEMBER 1972

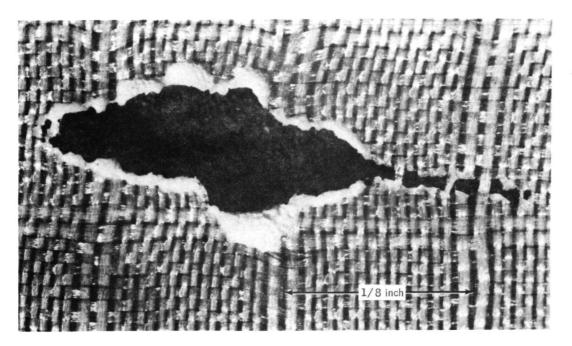
(a) Apollo 4 parachute.

The canopy of one of the recovered main parachutes had numerous small burn holes similar to the burn holes observed on parachutes from previous missions (see fig. 1). The cause of the holes found on previous missions had been attributed to oxidizer from the reaction control system.

Figure 1.- Typical burn holes found in recovered parachutes.

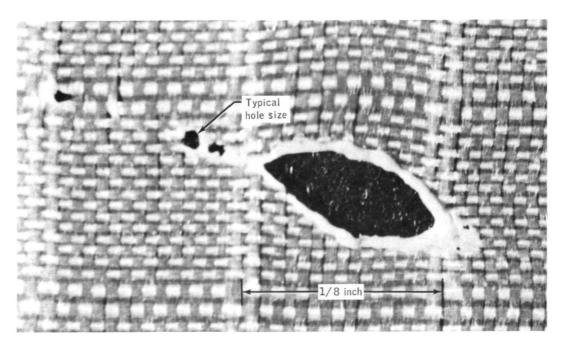
(b) Apollo 16 parachute.

The burn holes in the parachute were the result of oxidizer being expelled when the plus-yaw engines were fired as the spacecraft was in the final phase of descent. The engine firing is not required to relieve the manifold pressure.

For Apollo 17 and subsequent missions in which the Apollo spacecraft is used, the command module will be landed with the reaction control system pressurized and the propellant isolation valves closed.

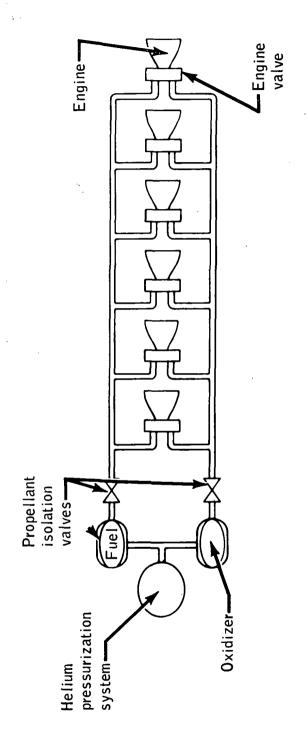
Figure 2.- Command module reaction control system engine manifold schematic.

Tests and analyses were performed to determine the capability of the system to withstand the pressure rise and to establish whether or not the engine firing was necessary to relieve manifold pressure. Results showed that system pressures can exceed 4800 psia, if not relieved. The isolation valves, however, will normally relieve the back pressure through the valve at 650 to 800 psia as shown in figure 3, and if the poppet sticks closed, the pressure will be relieved through the valve seal at 3400 psi. Pressure capabilities of the remaining components are 6200 psia and 5000 psia for the propellant lines and flexible lines of the system and manifold assembly, respectively, and 5000 psia for the engine valves.
